# 24" (650mm) Bespoke Fabricated Encapsulation Collar - Bournemouth

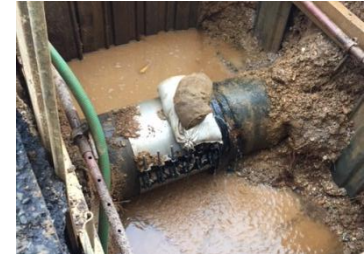
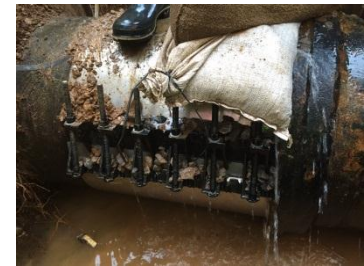
Leaking temporary repair clamp

On Wednesday 6<sup>th</sup> January 2016 R2M's technical support team was called to attend a leak in Wimborne near Bournemouth where a temporary repair clamp had been installed on a 24" cast iron main, but itself was leaking. It was immediately deemed suitable for an R2M encapsulation collar using R2M's tried and tested Duofit sealing system, but with a longer, fabricated body in order to encapsulate the stainless steel repair clamp.

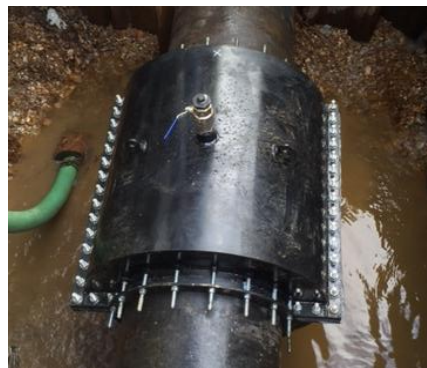
Final plug tested, valve in off position, repair complete

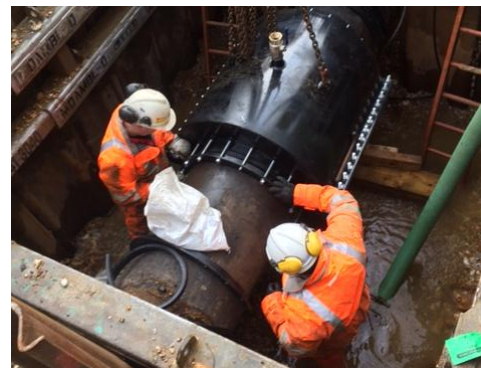
First End Ring Installed

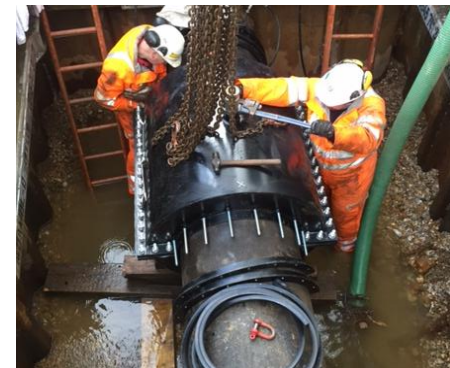
Installation of new clamp under-way – top & bottom shells in place
