# Case Study – 54" Encapsulation - Our Largest Live Encapsulation So far

During the 7<sup>th</sup> & 8<sup>th</sup> October, R2M Site Services installed a 1350mm Nova Siria Duofit encapsulation collar over a leaking flange connection.

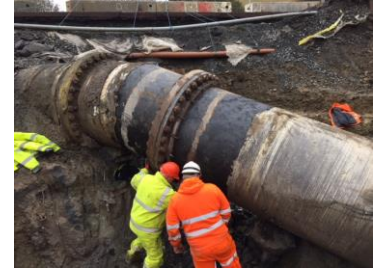
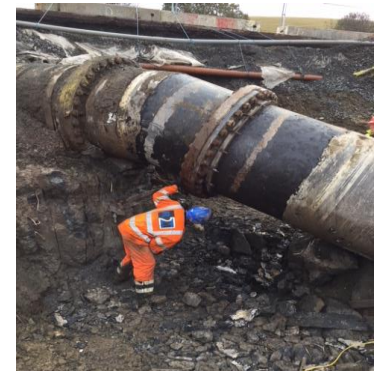
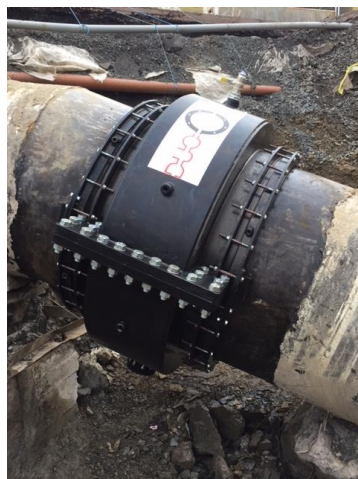
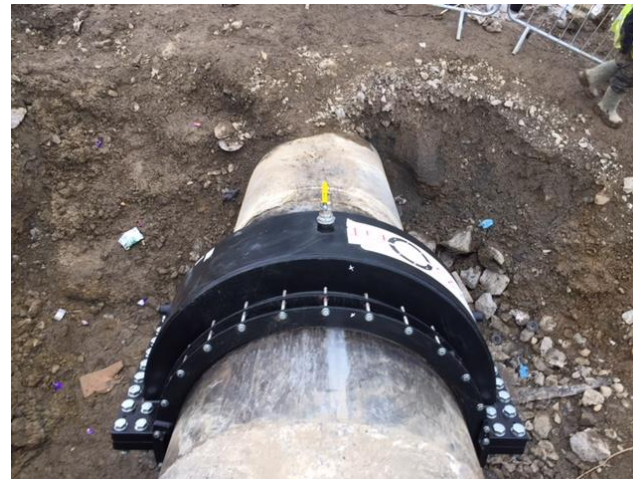
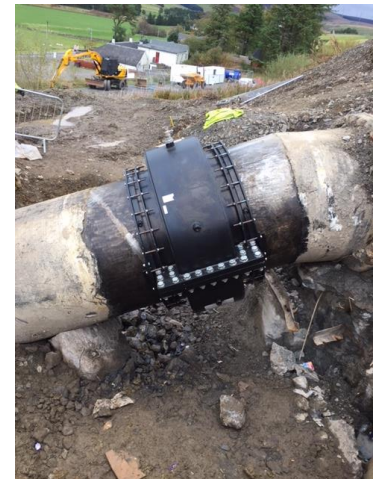
The pipe was bitumen coated steel and required a large amount of preparation in order to create a suitable surface to seal onto and the Nova Siria Duofit's 30mm range is ideal in cases such as this where the coating makes accurate measurements difficult to take prior to making the installation.

A further complication was the angled plane of the pipe although r2M Site services experienced team were easily able to coordinate the mechanical lifting required in order to fit the main halves of the clamp.

The installation was leak tested once up to full pressure and completed with a commissioning valve as a final turn off point.

A permanent repair was made with no disruption or de-pressurisation.
