# Case Study – 32" Live Duofit Encapsulation on Severe Leak

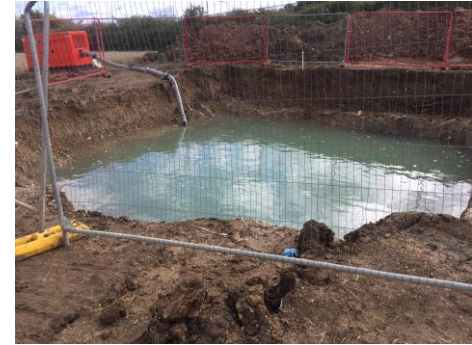
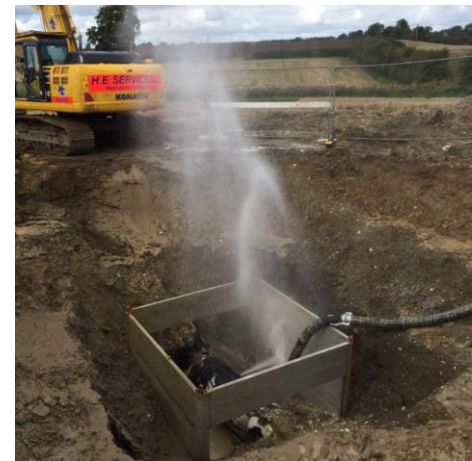
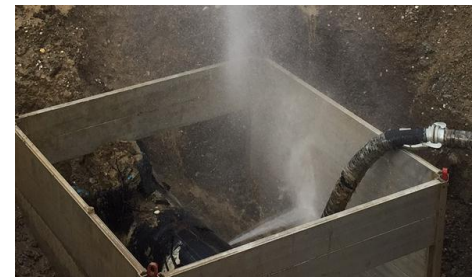
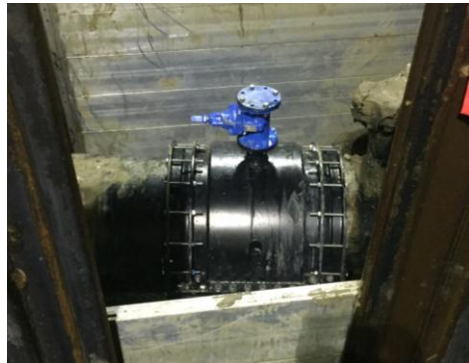
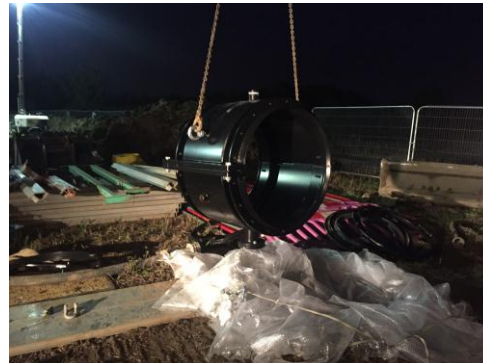
During the night of 3<sup>rd</sup> October, R2M Site Services installed an 32" Nova Siria Duofit encapsulation collar and repaired a severe leak at 5.5bar. The severity of the leak was such that a 50mm jet of water was ejecting from the pipe horizontally and was then making a vertical geyser approximately 20ft into the air!

It was questioned as to the possibility of making a live repair although R2M Site Service's experienced team were able to bring the leak under control with the main casings of the Duofit, which then suppressed all spray, enabling the end ring seals to be installed and the repair completed with a 100mm gate valves vent. This was still a challenging installation due to the heavy bitumen coating on the pipe which had to be cleaned off in order to gain a seal. This meant the installation took circa 6hours.

The pipe measured 814mm which was perfect for the Duofit's range of 800-830mm. The Duofit was supplied from R2M's standard stock range on a next day service.

I full live, permanent repair was made with no disruption to any of the customers supplies.
